Preliminary Analysis Report

Bryson v. Rough Country, LLC

Mecanica Case Number: 22-3104

Date of Collision: March 15, 2020

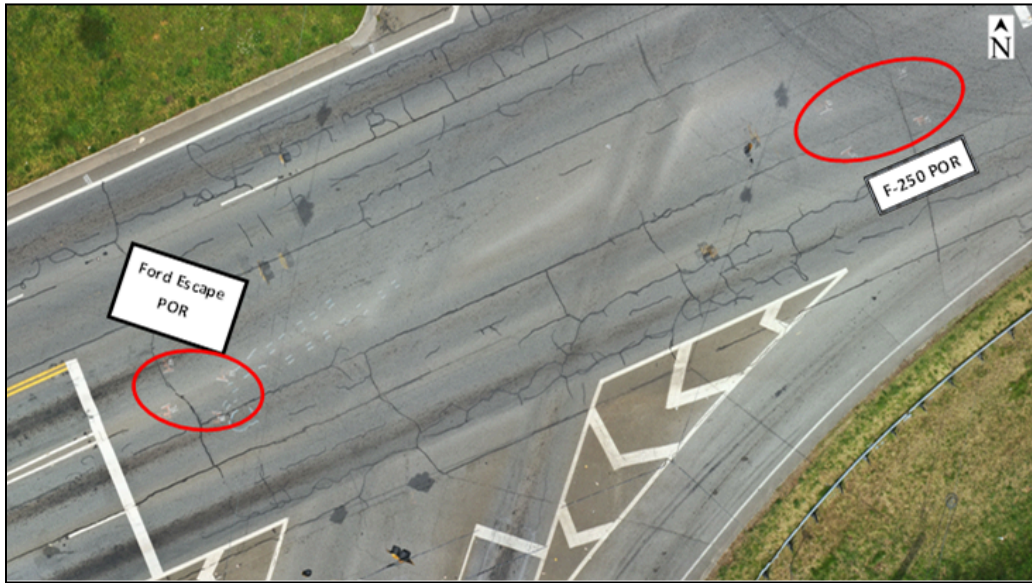
Figure 2 is an orthomosaic created from drone aerial photographs of the site showing a close-up of the intersection. In the orthomosaic (**Figure 3**) the police markings indicating the rest positions of the vehicles were observed. From the SCRT Report, the F-250 was moved after it originally came to rest. The police report identified the collision site as 25 feet east of Blue Ridge Drive on Georgia 2.

Figure 3: GDPS aerial view with points of rest marked

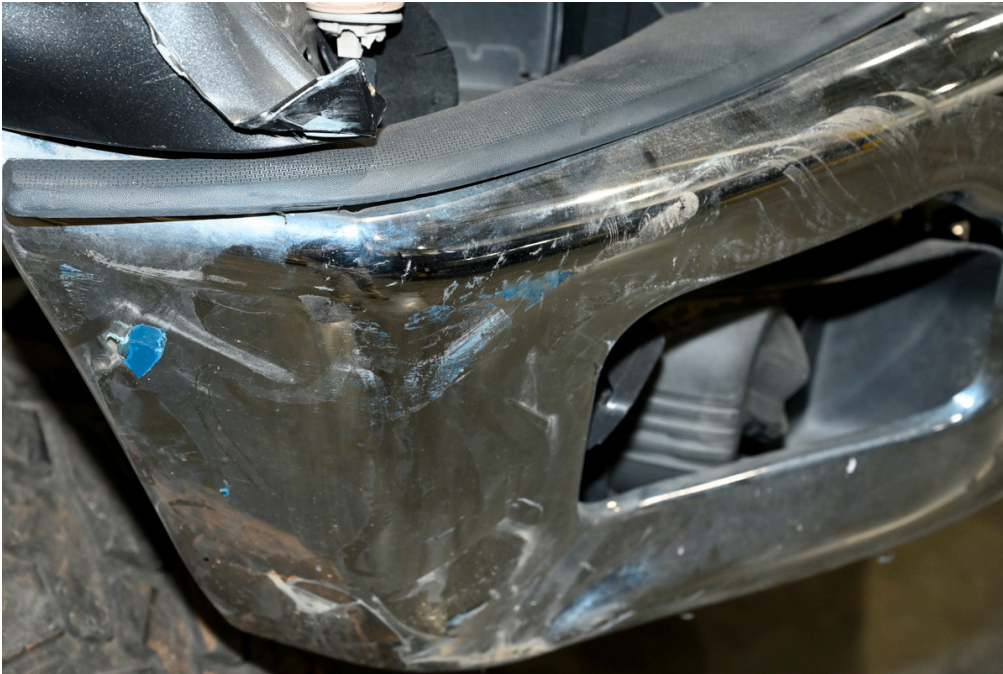
There were blue and white markings on the right corner of the bumper (**Figure 6**).

Figure 6: Ford F-250 right corner of the front bumper

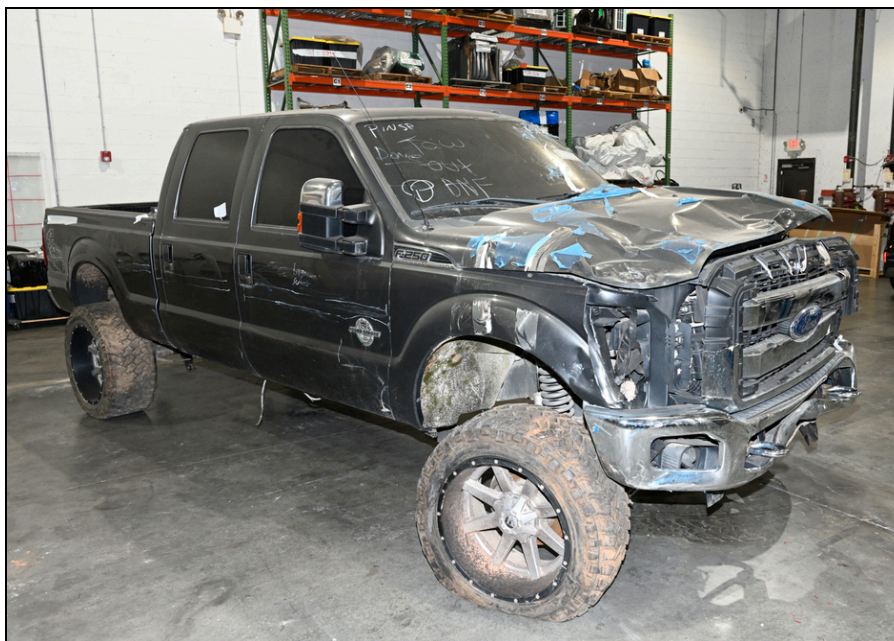
The right side of the vehicle had two horizontal scratches from the front of the right-front door to the rear of the right-rear door (**Figure 7**). However, these scrapes could not be clearly seen in the police photos (**Figure 8**) and there appears to be dried mud sprayed up over them, indicating they likely did not come from this incident.

Figure 7: Right front of Ford F-250 showing scratches on right side of vehicle

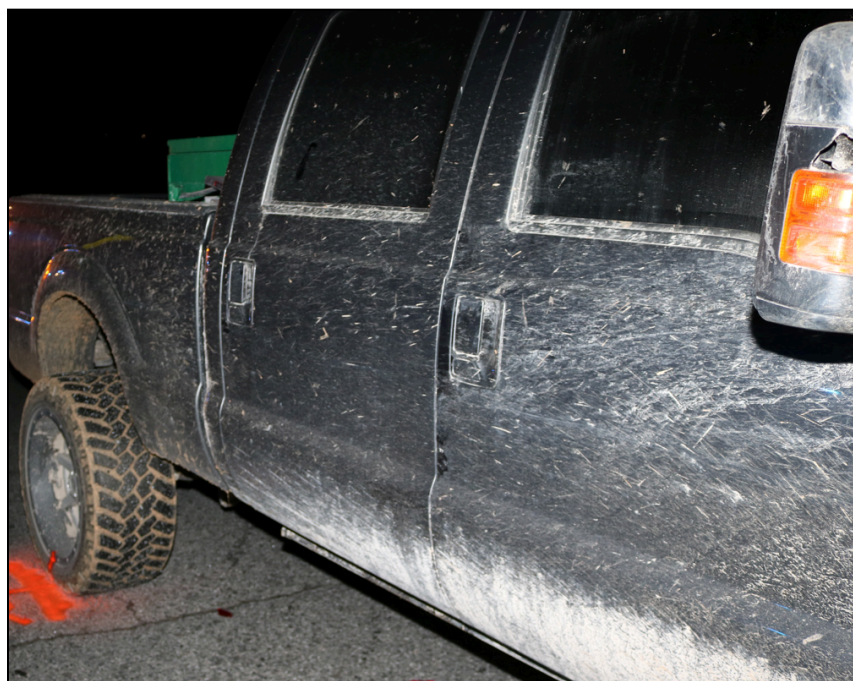
Figure 8: Police photo showing no scratches on right side of vehicle

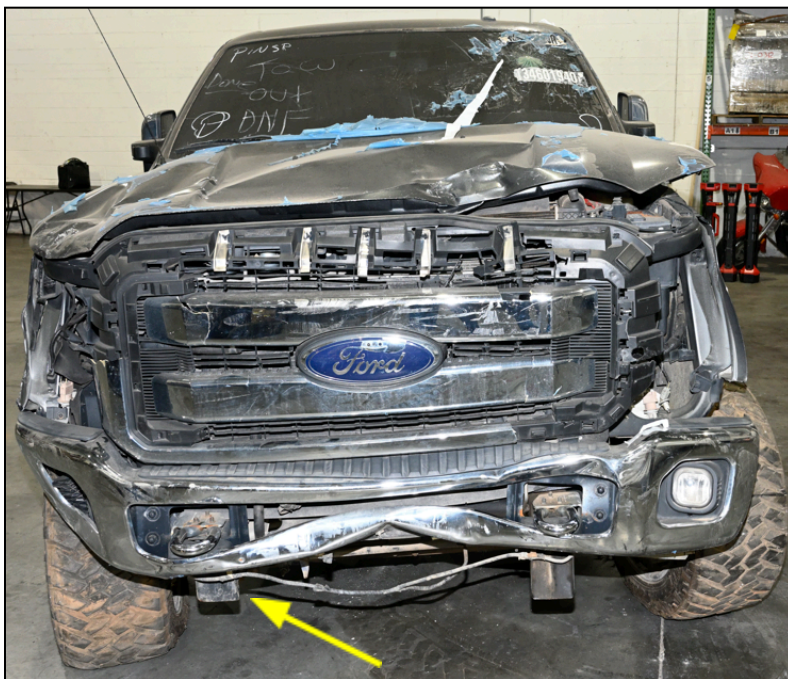
The bottom of the right Secondary Energy Absorption System (SEAS) was displaced rearward, see **Figure 9**. The left SEAS is angled with the bottom portion slightly forward. The left side of the windshield was fractured. The left edge of the front bumper is rotated downward. The left

Figure 9: Front of Ford F-250 - right SEAS bracket displaced rearward

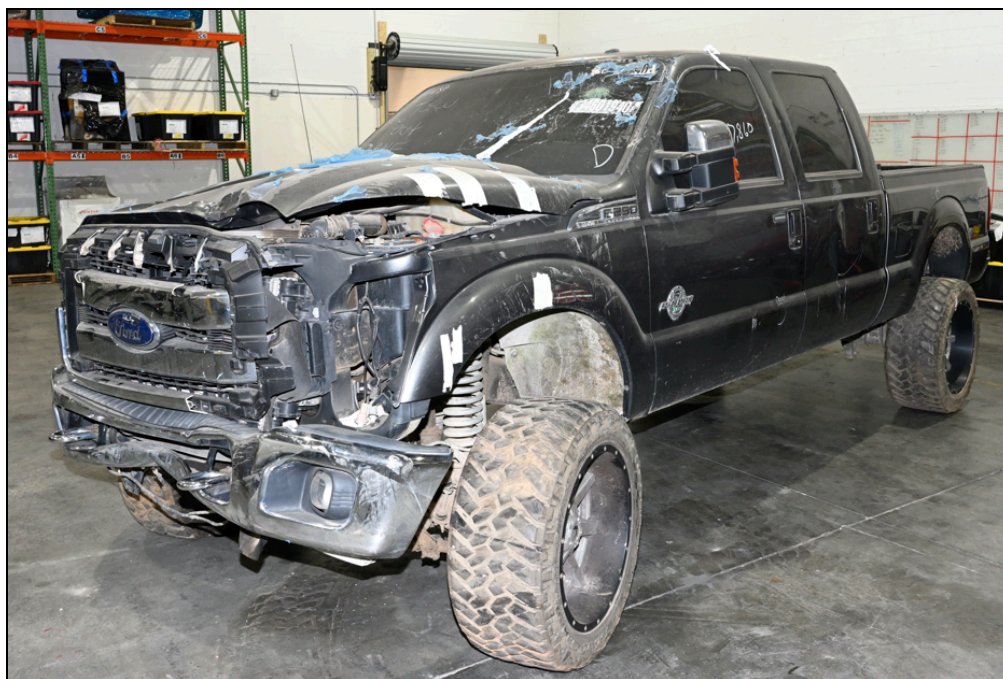
front tire was rotated to the left. There were vertical scrape marks on the trim above the left front tire (**Figure 10**). The rear of the vehicle appeared undamaged.

Figure 10: Left front of Ford F-250

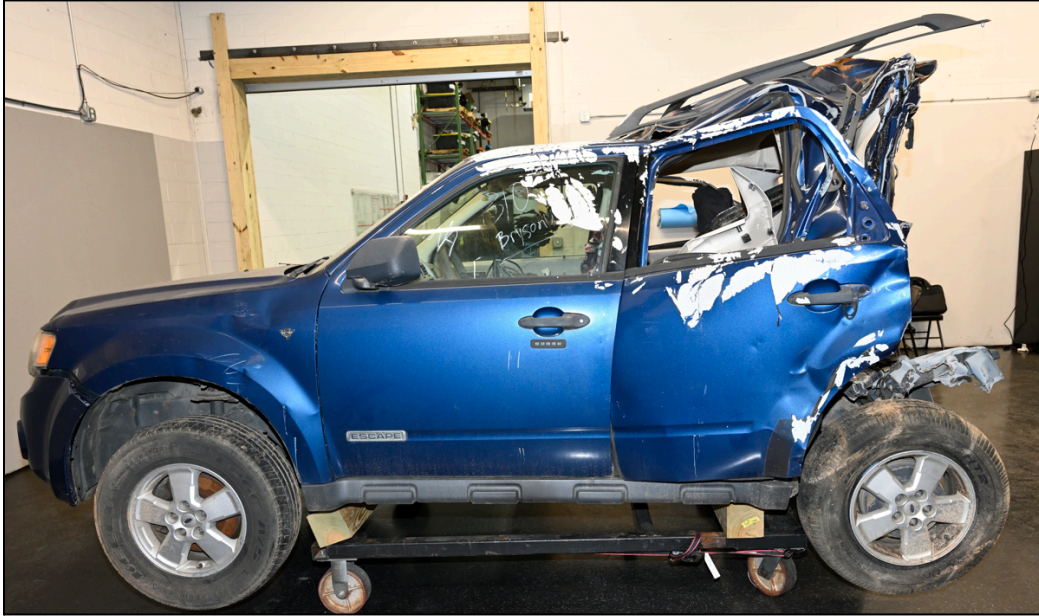
The rear of this vehicle sustained heavy damage. The left rear door is displaced forward and upward. The left rear fender is distorted and crumpled forward of the rear axle and the left

C-pillar and D-pillar were in close proximity, see **Figure 11**. The bottom of the hatch was distorted forward of the rear axle and the rear window was not present. (**Figure 12**). The rear roof line was displaced upward and forward. The right fender was also distorted and displaced forward. Sections of the right side C and D-pillars were also in close proximity and the top, aft section of the right rear door was displaced downward, see **Figures 13-14**.

Figure 11: Left side of Ford Escape

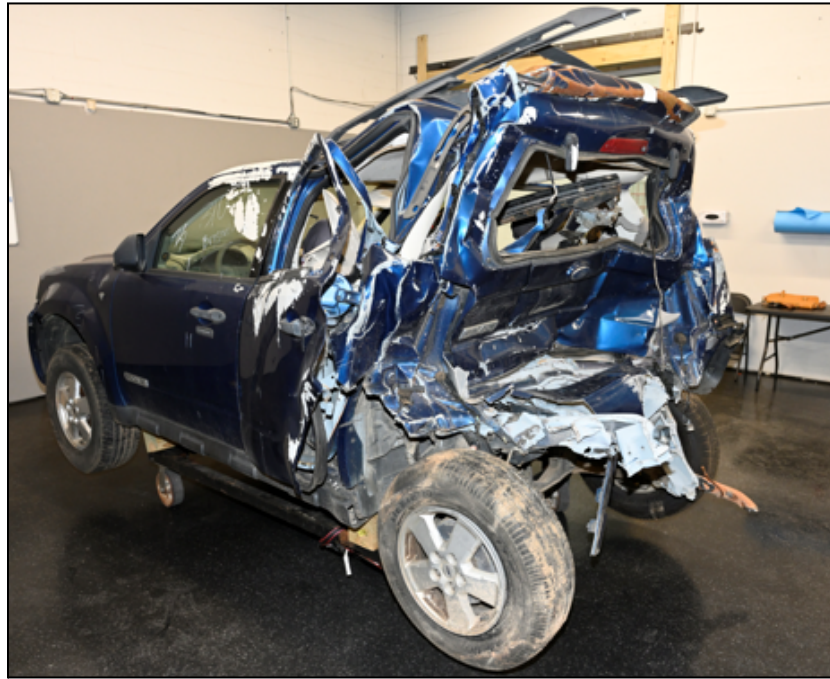
Figure 12: Left rear corner of Ford Escape

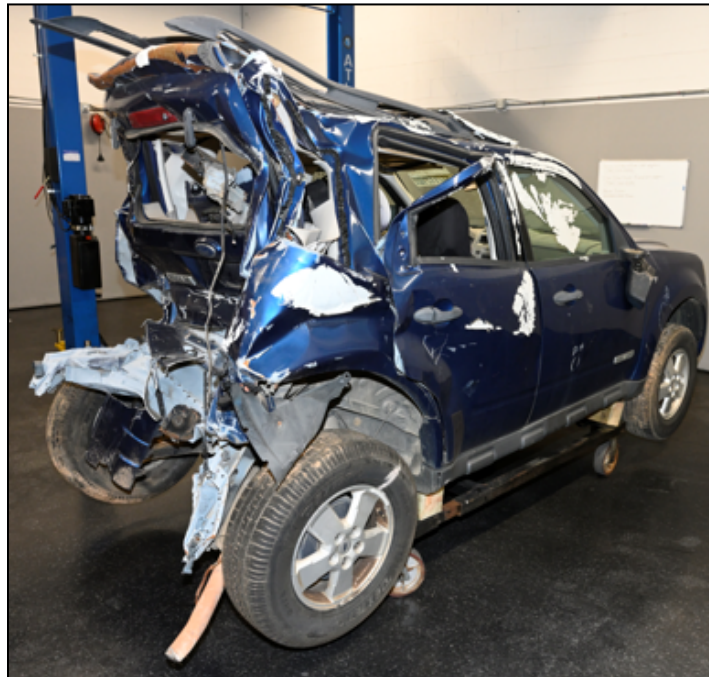
Figure 13: Right rear corner of Ford Escape

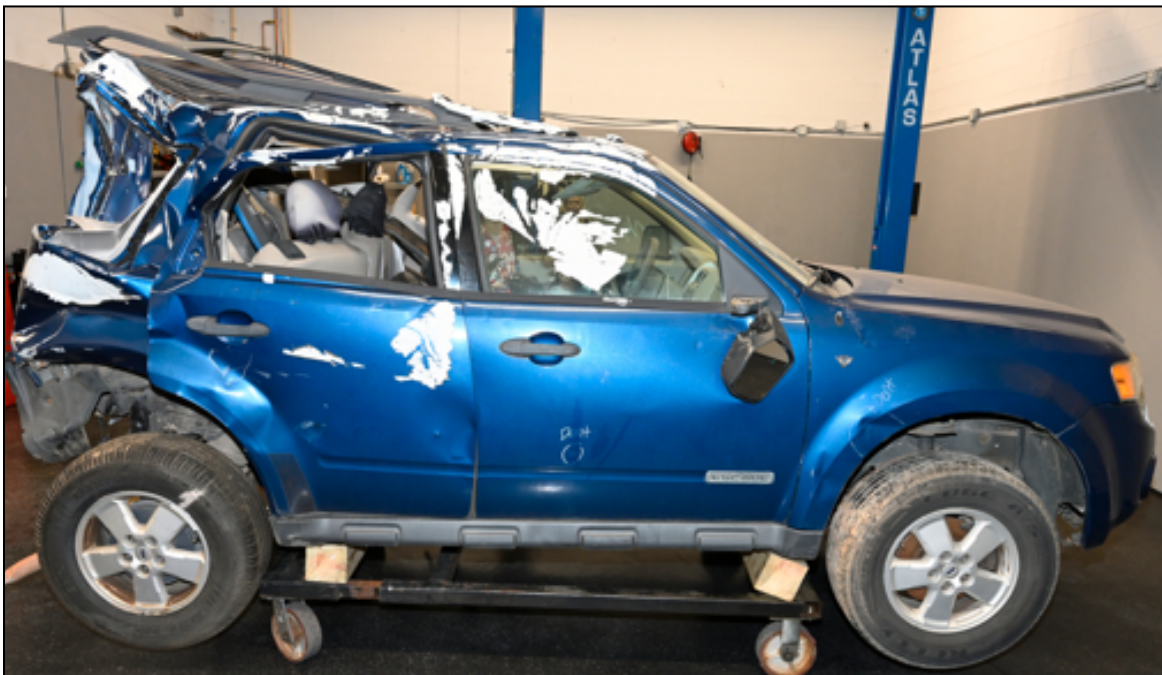
Figure 14: Right side of Ford Escape

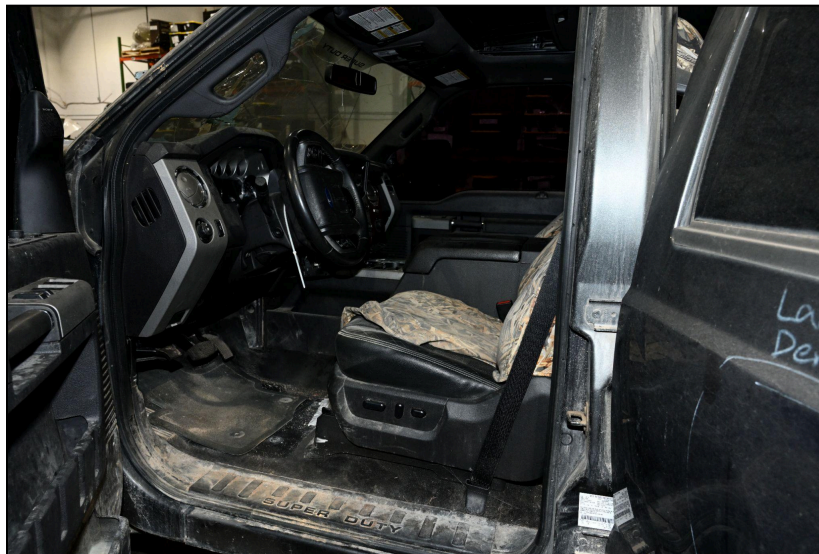
The Deployment data from the CDR report indicated the maximum longitudinal delta-V as -18.21 mph and the maximum lateral delta-V as -0.76 mph. Mr. Buchner reported the last longitudinal and lateral delta-Vs in the respective tables. Although these were the last values in the respective tables, they are not the values at the end of the event. 49 CFR 563 states, the end of event time is the moment at which the cumulative delta-V within a 20 ms interval becomes 0.5 mph or less. For this crash, the end of the event was approximately 141 ms after Time 0. At 141 ms, the longitudinal delta-V was -17.48 mph and the lateral delta-V was -0.40 mph. Based on these delta-Vs, the Principle Direction of Force (PDOF) was from approximately 12 o'clock.

Figure 23: Front occupant area of F-250 showing the airbags did not deploy in this crash

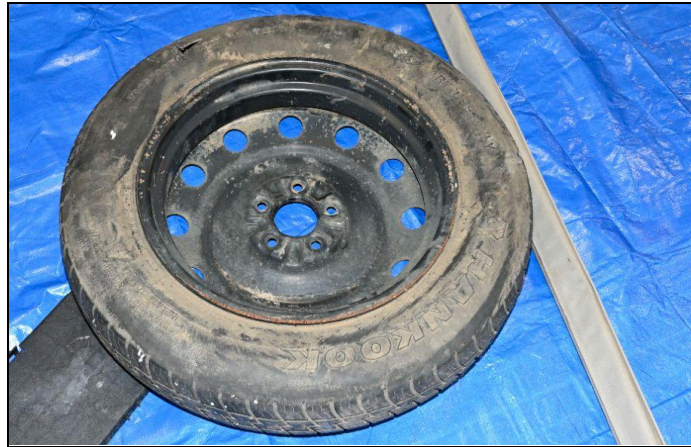
There was damage to the inner wheel flange of the spare tire consistent with the damage mentioned by Mr. Buchner (**Figure 24**).

Figure 24: Damage to the spare tire wheel of the Escape

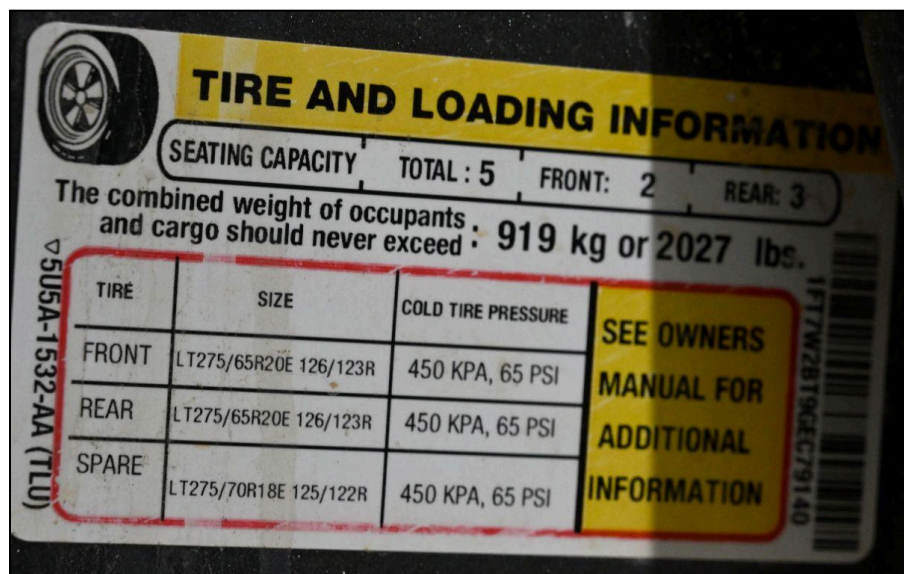
On page 6 of the report, Mr. Buchner used a 2015 Ford F-250 Super Duty, Crew Cab, four-wheel drive pickup with LT275/70R18 tires as an exemplar vehicle. Although the VIN for Mr. Buchner's exemplar F-250 was not given, the Tire and Loading Information decal on the left B-pillar of the subject vehicle (**Figure 25**) shows the recommended tire size for the subject F-250 was LT275/65R20. The difference between the diameter of the tire sizes of Mr. Buchner's exemplar F-250 and the recommended tire size of the subject F-250 is approximately one inch. This would decrease the height of Mr. Buchner's F-250 by approximately one half inch over the 2016 Ford F-250 involved in this crash.

Figure 25: Tire and Loading Information from the Subject F-250

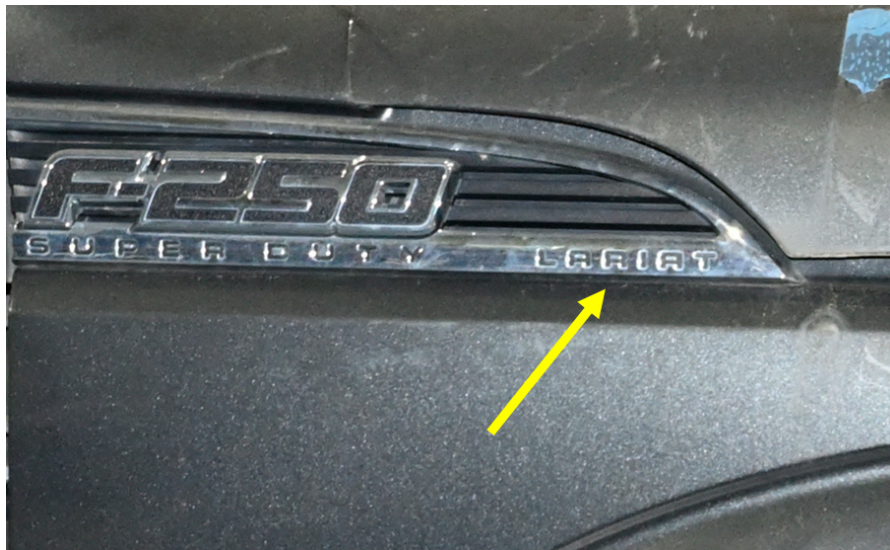
Mr. Roche's report addresses vehicle crashworthiness and vehicle compatibility issues. This is outside the area of this report and will not be addressed herein, except where the report discusses the reconstruction of the crash. On page 7 of the report, Mr. Roche states the subject F-250's trim level was a King Ranch. The trim level of the subject F-250 was in fact a Lariat (Figure 26).

Figure 26: Trim level of the subject F-250

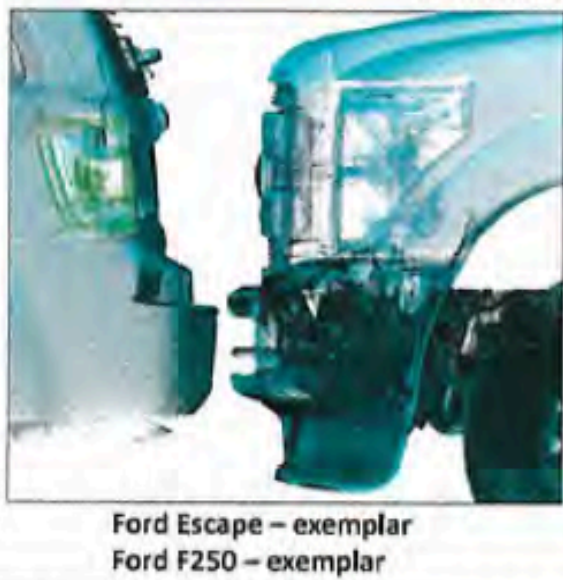
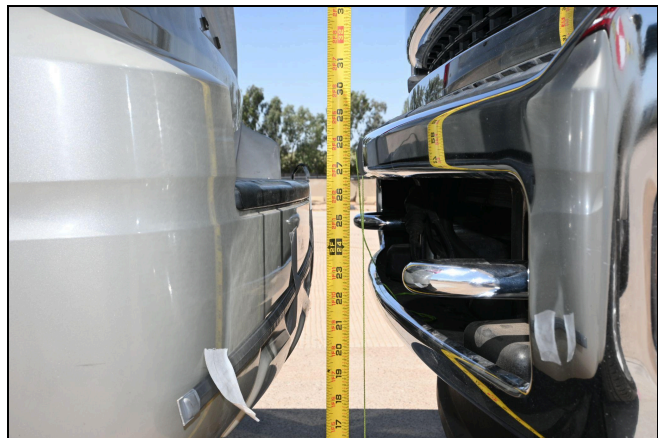
On page 26 of his report, Mr. Roche opines that if the crash had occurred with a regular, non-lifted F-250 with sufficient compatibility, as shown in image 23, then the risk of intrusion into the occupant compartment survival space would have been reduced. **Figure 27** shows a comparison of image 23 from Mr. Roche's report and a similar view from the crash test setup photographs. No data was presented for the exemplar Escape or exemplar F-250 Mr. Roche used in his vehicle alignment, except that the bumper heights were used from FMVSS 301 test data. In all the NHTSA crash testing for the 2016 Ford F-250, the tire size was LT275/65R18. The recommended tire size on the subject F-250 was LT275/65R20. This indicates that Mr. Roche's analysis of the vehicle alignment was not accurate and his exemplar F-250 bumper height was incorrect by up to one inch.

Figure 27: Comparison of Mr. Roche's exemplar bumper heights and crash test bumper heights.

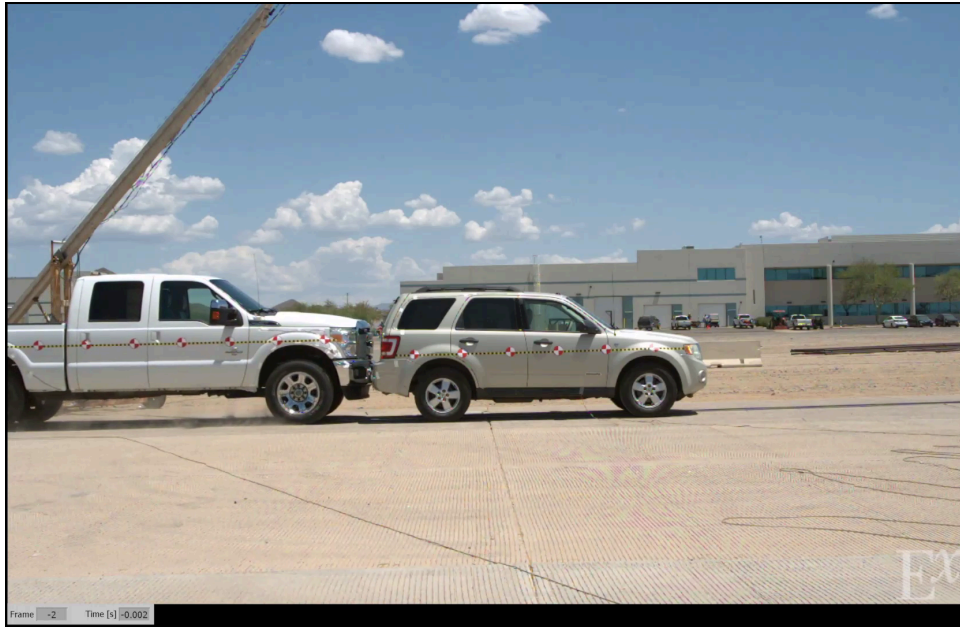
The front bumper of the F-250 and the rear bumper of the Escape were approximately aligned at impact (**Figure 30**). During the impact phase of the collision, the front bumper of the F-250 went over (overrode) the rear bumper of the Escape (**Figure 31**). This allowed intrusion of the front of the F-250 into the cargo area and displacement of the rear seat of the Escape. It also increased the load on the rear tires of the Escape, which deflated the left rear tire, similar to the subject collision.

Figure 30: Crash test impact showing relative bumper heights.

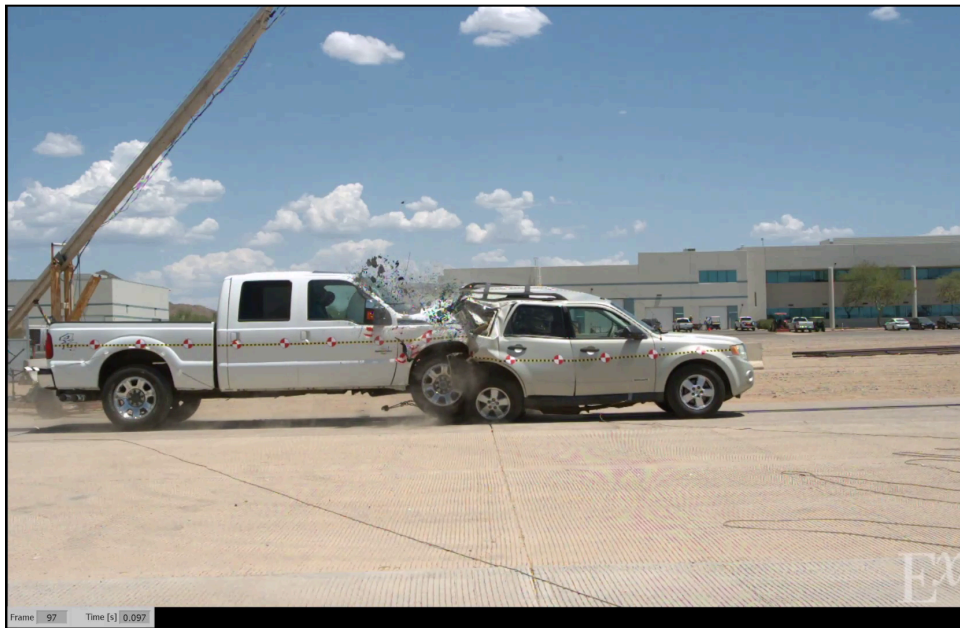
Figure 31: Crash test during impact. F-250 bumper overrode Escape.

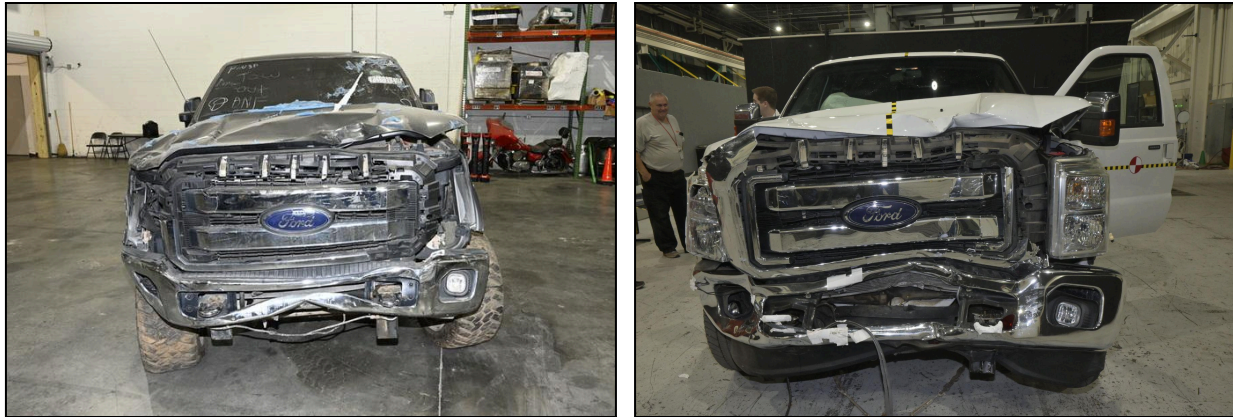
The damage to the F-250's front bumper was slightly different in the crash test when compared to the subject F-250 (**Figure 32 through 34**). This was expected since the crash test F-250 was equipped with the factory suspension and the recommended tire size. The location of the

deformation to the center of the front bumper was substantially similar. Both F-250s had similar deformation to the hood, grille and deformation to the ends of the front bumper.

Figure 32: Front of the subject F-250 (left) and test F-250 (right)

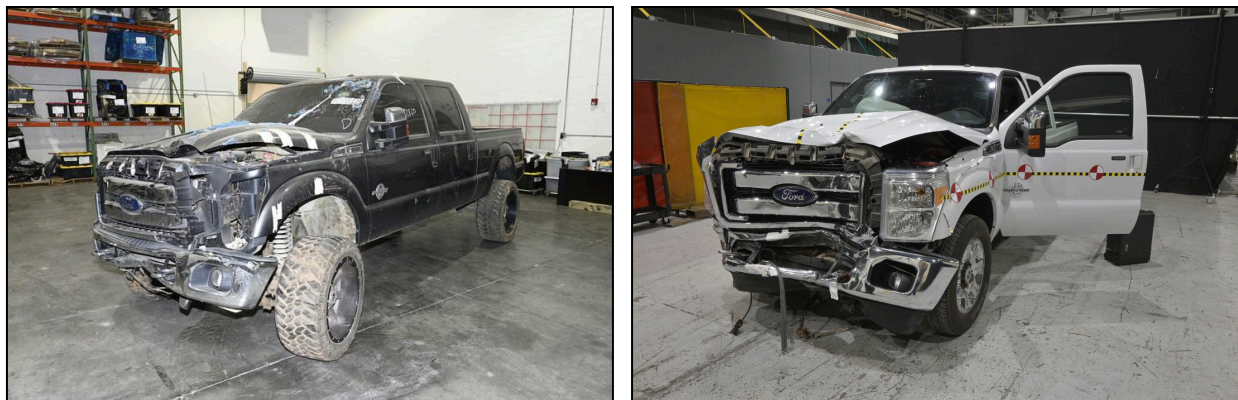
Figure 33: Left-front view of the subject F-250 (left) and test F-250 (right)

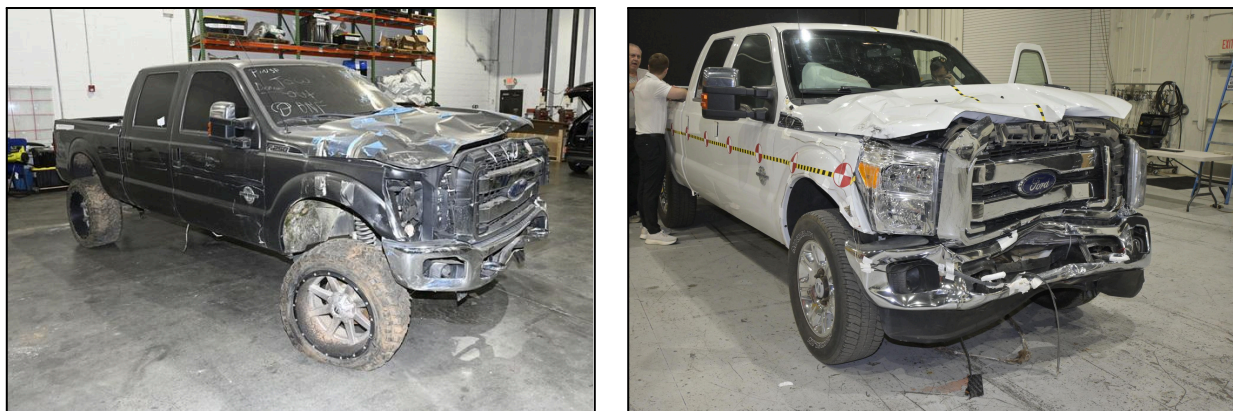
Figure 34: Right-front view of the subject F-250 (left) and test F-250 (right)

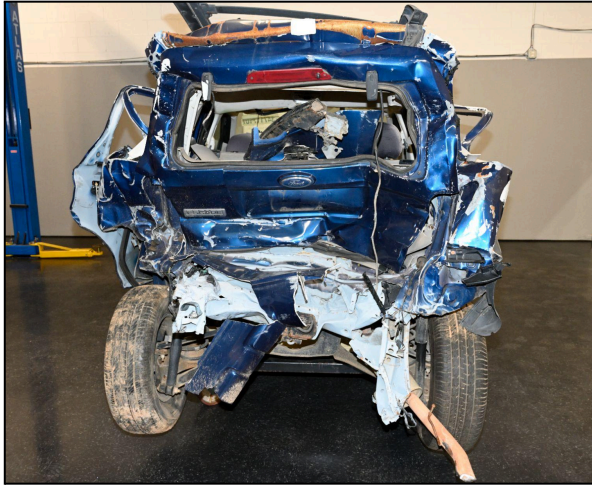
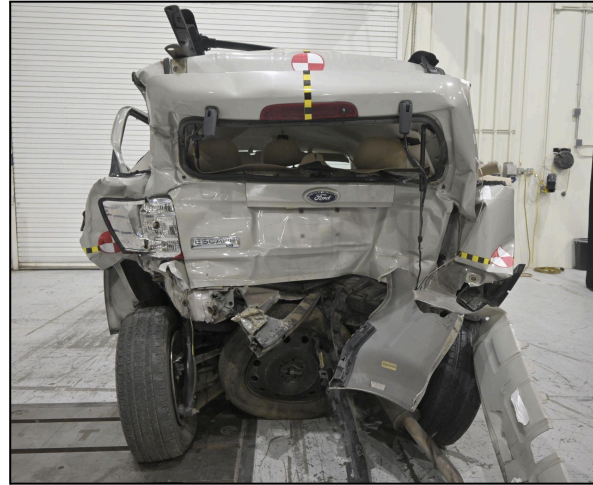
The damage to the test Escape was slightly different than the subject Escape. This was expected due to the differences in the subject and test F-250 equipment (**Figures 35 through 37**). There were also significant similarities between the subject and test Escapes. The C-pillars and D-pillars were both displaced forward, the top of the rear lift gate was rotated downward, the crease in the rear tailgate was below the right rear-window hinge.

Figure 35: Rear view of the subject Escape (left) and test Escape (right)

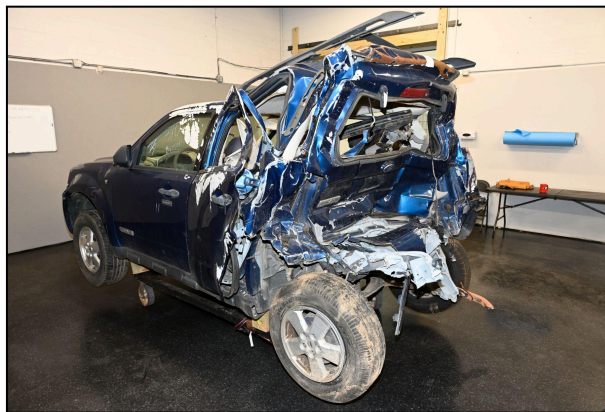
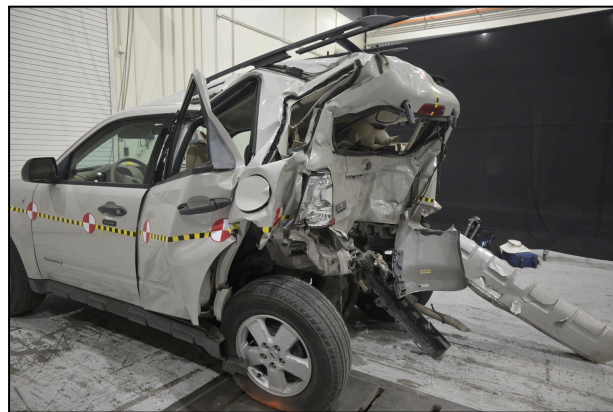
Figure 36: Right-rear view of the subject Escape (left) and test Escape (right)

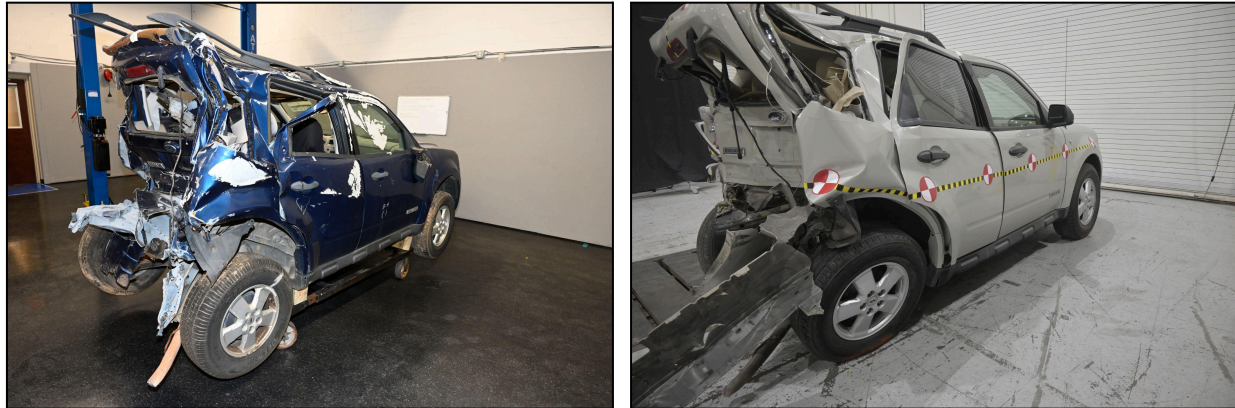
Figure 37: Right-rear view of the subject Escape (left) and test Escape (right)

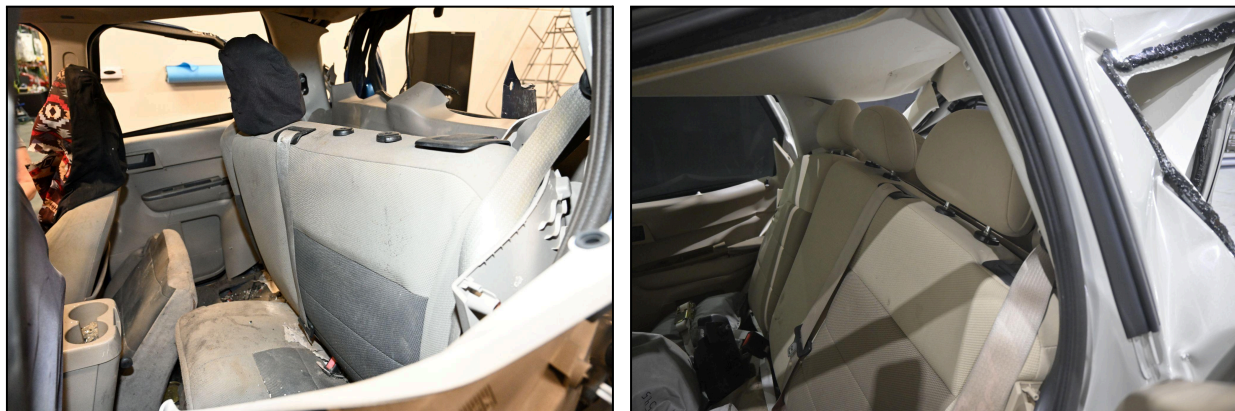
Both rear seats were displaced and deformed (**Figure 38**). The difference in the seat deformation in both Escapes was probably due to the lack of cargo in the rear cargo area of the test Escape. The test Escape would have sustained more seat deformation had exemplar cargo been placed in the rear cargo area since the rear hatch of the test vehicle had to be displaced through the entire rear cargo area to contact the rear seat back. Had exemplar cargo been identified and placed in the cargo area, the cargo would have been sandwiched between the rear seat back and the rear hatch and subsequently applied a force to the back of the rear seat as it was displaced forward.

Figure 38: Seat back deformation of the subject Escape (left) and test Escape (right)
